Project: Floating crude-oil tank roof
Location: Fawley, west of Southampton, England
Completed: September 2007
Specification: Zinga 120-140µm

Project Study

Project: Floating crude-oil tank roof
Location: Exxon Mobil, Fawley, west of Southampton, England
Completed: September 2007
Specification: Zinga 120-140µm

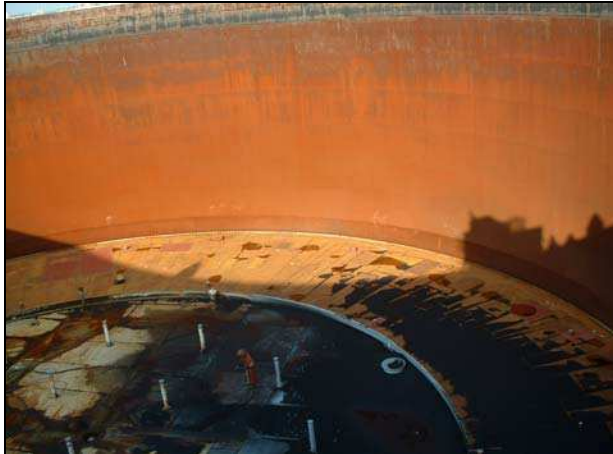
Roof-top showing corroded paintwork

Solution: Blast-clean the entire surface and apply Zinga to a thickness range of 120 - 140µm DFT.

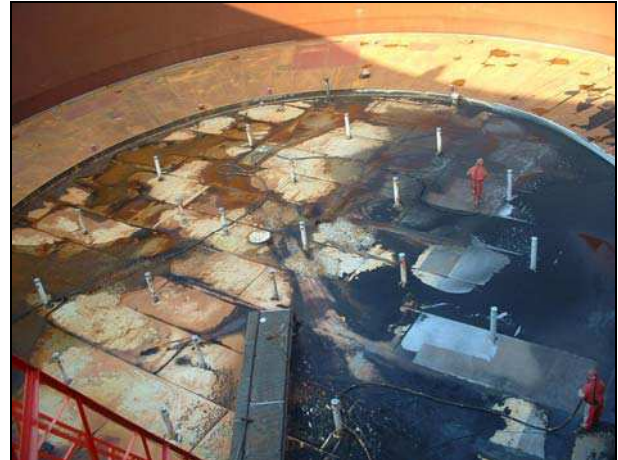
View of roof showing spent blast-media

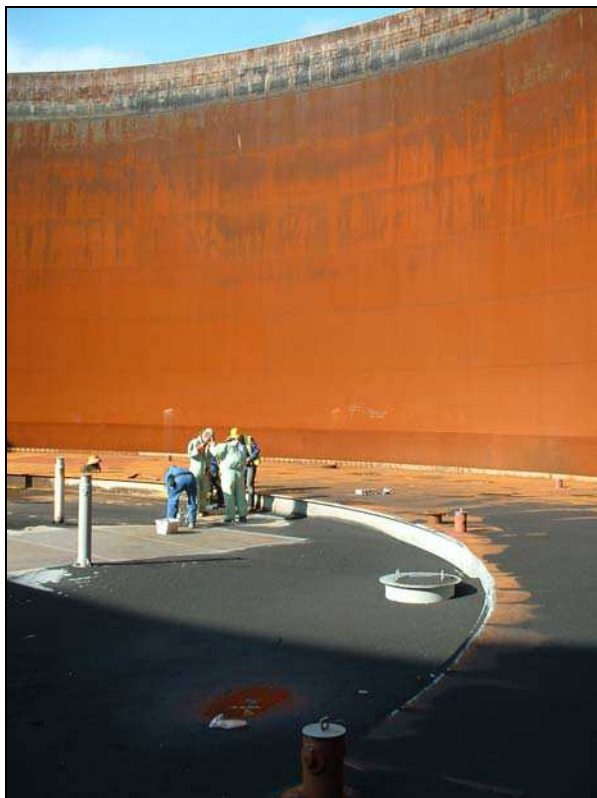
Close-up view showing true size

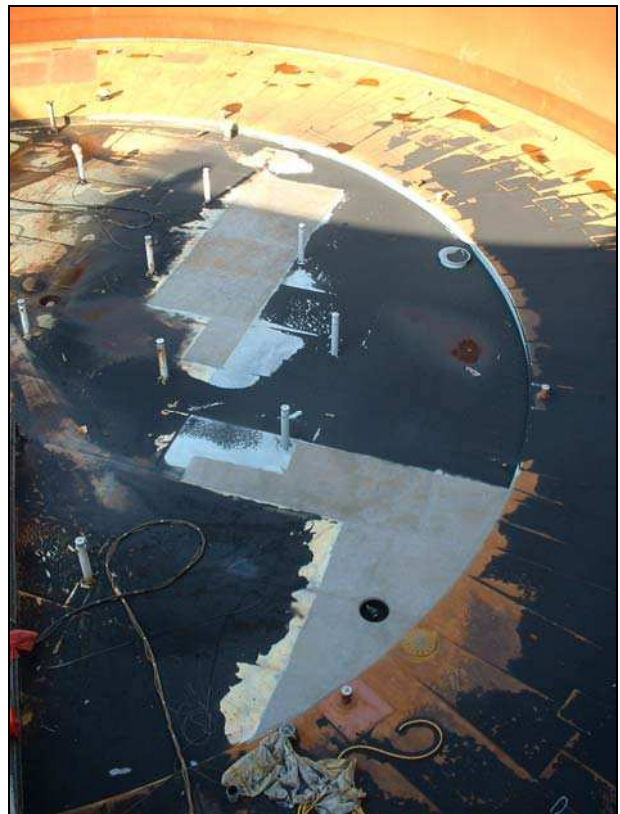
Aerial view showing blasted areas

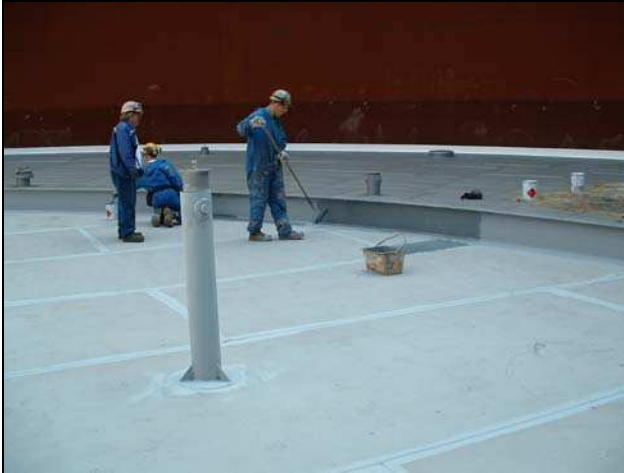
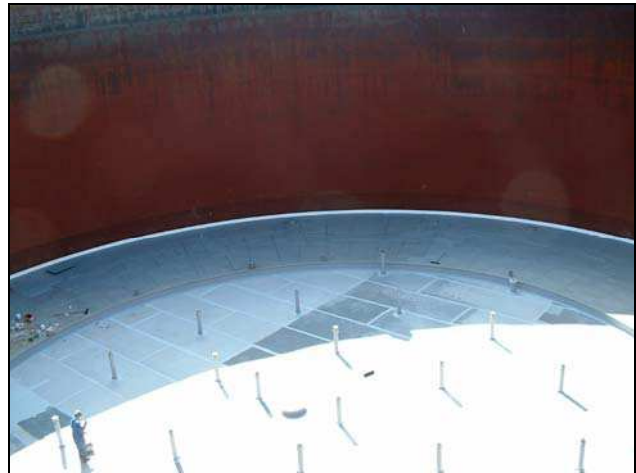
Problem: The crude-oil floating tank-roof was corroded. The tank farm is adjacent to the sea and the contracting team had previously had problems when applying epoxy coatings. Their blast hoses were dragging across the wet epoxy which was surface dried but was still soft underneath.
